**REPORT OF INVESTIGATION**

**Surface Metal Mine  
(Copper)**

**Fatal Powered Haulage Accident  
July 27, 2017**

**Asarco LLC  
Mission/San Xavier/ Eisenhower  
Sahuarita, Pima County, Arizona  
Mine I.D. No. 02-00135**

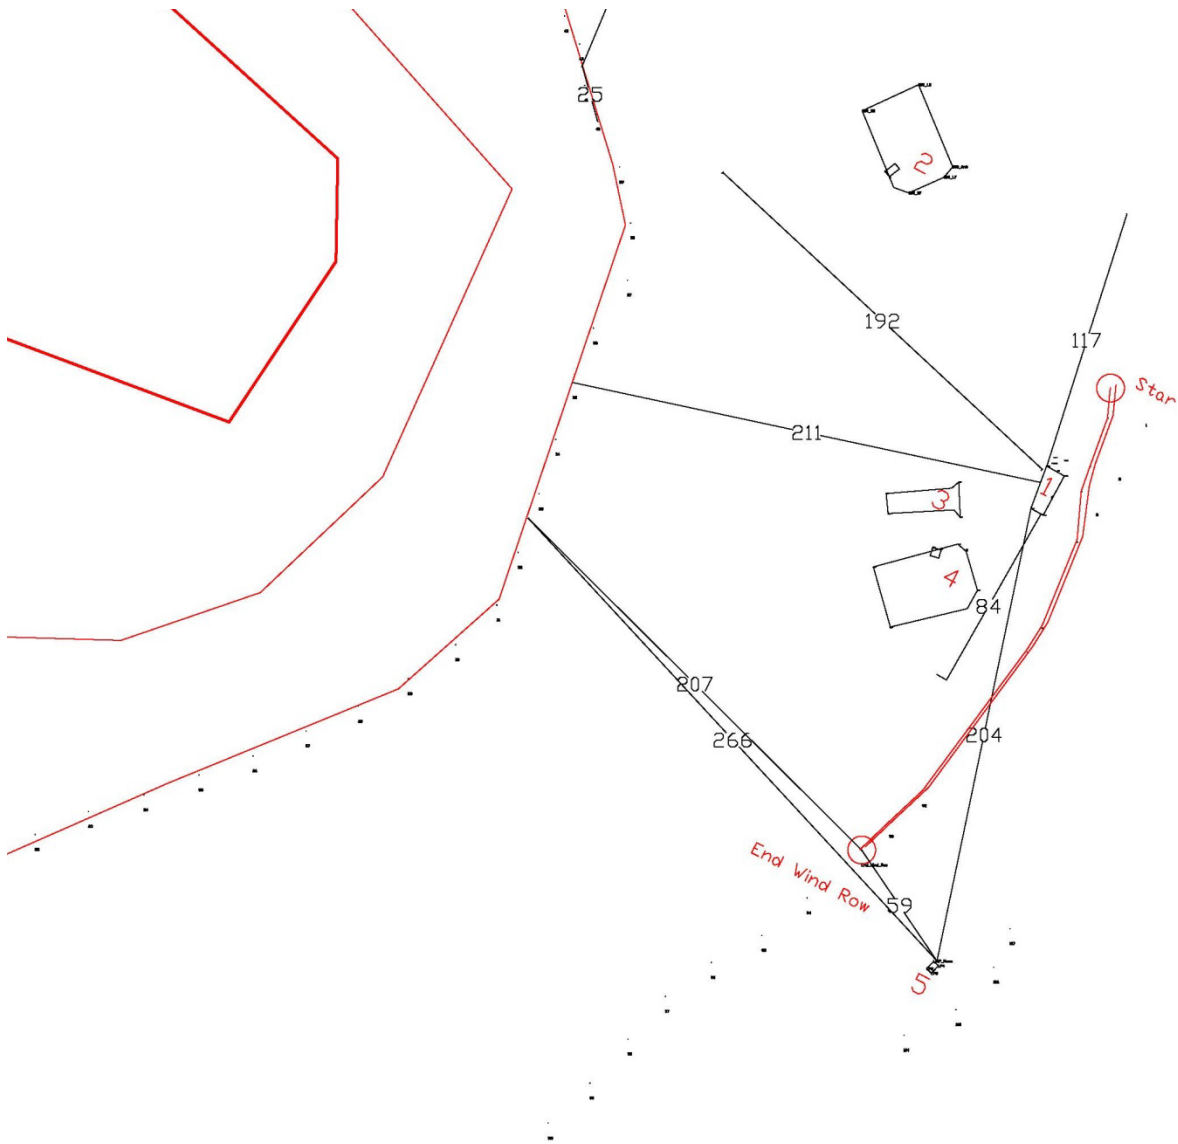
Figure 1: Final Accident Scene Vehicle Locations

At 8:33 p.m., Johnny Tynes, Heavy Truck Operator, entered the 3450 dump site in a Komatsu 930E-4, 320-ton haul truck, company number 316. Lopez directed Tynes to begin dumping further north (Figure 1). After dumping his load, Tynes began leaving the dump site. Nick Gomez, Heavy Truck Operator, entered the 3450 dump site in a Komatsu 930E-1, 320-ton haul truck, company number 390. Tynes made a large arcing turn in leaving the dump site to allow more room for Gomez's haul truck.

Investigators found one light plant at the 3450 dump site, but it was positioned facing the previous dump location. The operator did not reposition the light when the dump site moved to the north, and the victim's location at the 3450 dump site was not illuminated at the time of the accident. Additionally, investigators observed only three of the four lights of the light plant were operational.

1	F-550 Pickup
2	390 Haul Truck
3	401 Rubber Tire
4	316 Haul Truck
5	Light Plant

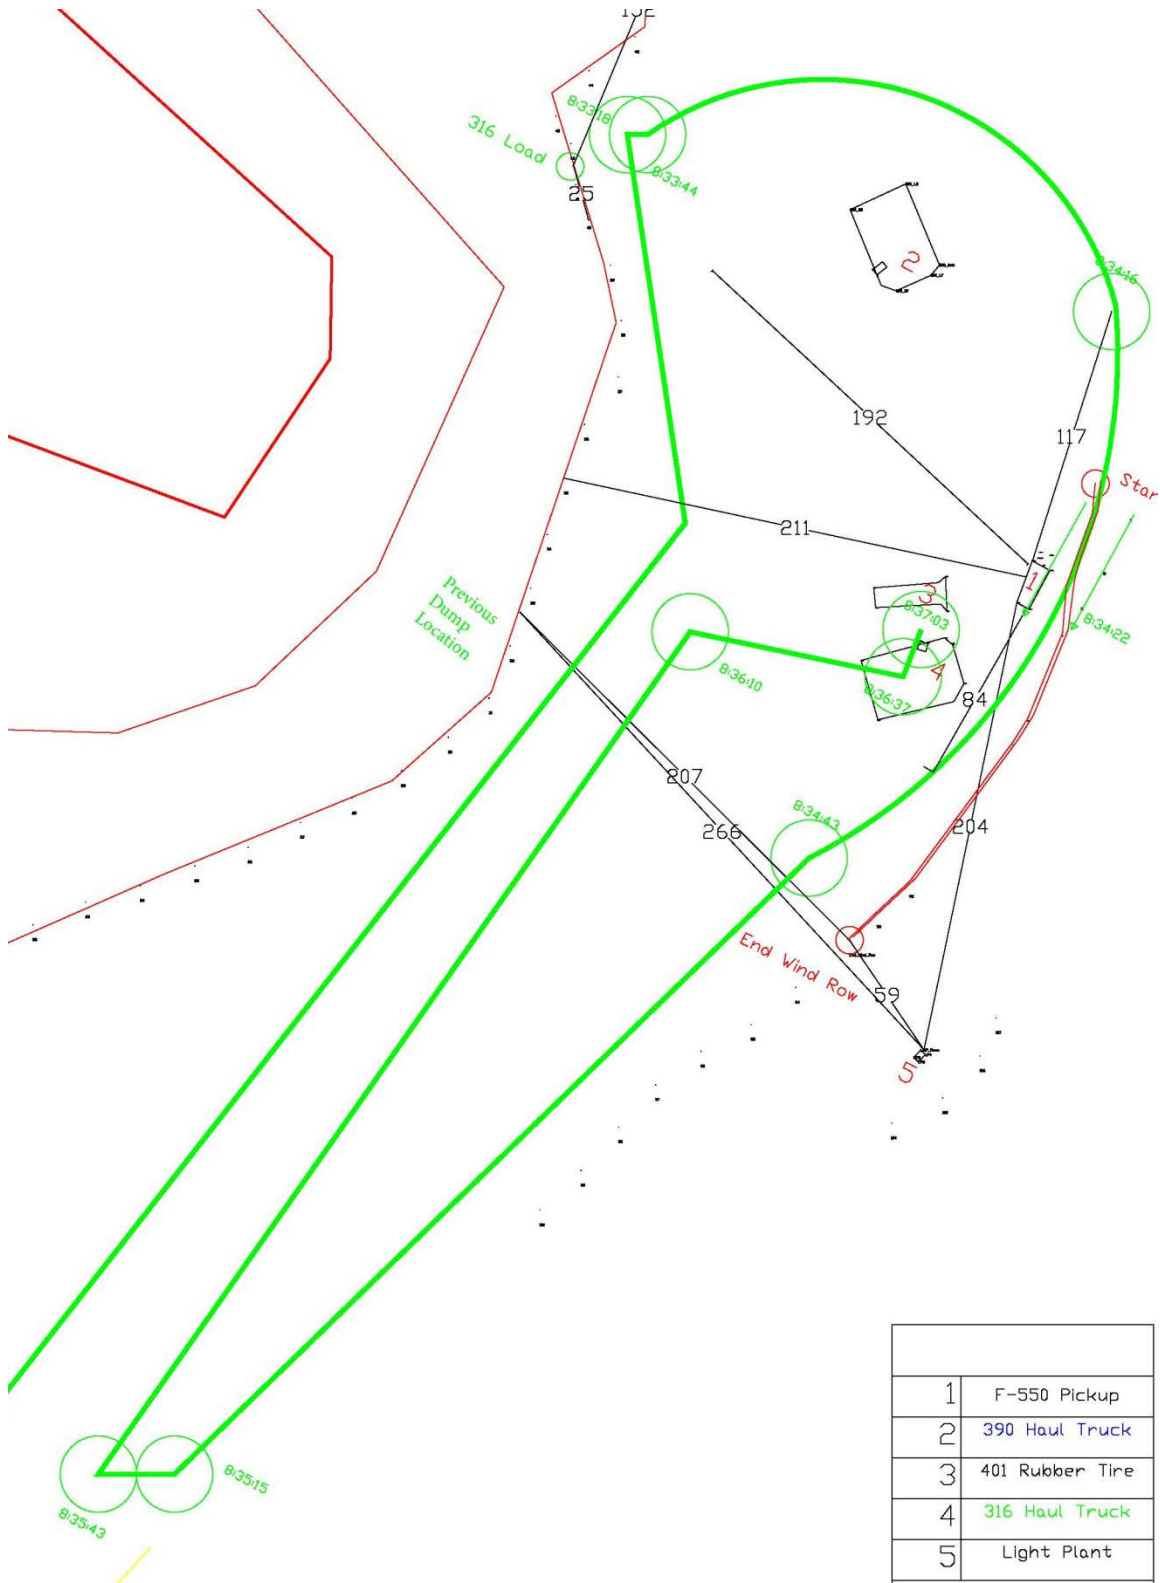
Figure 2: Path of Truck 316

As the two haul trucks approached each other, Tynes felt the haul truck rock back and forth as though it had hit something. After the two haul trucks passed each other, Tynes made a U-turn to see what he had contacted to determine if

Lopez would need to clean the area with the rubber-tired dozer (Figure 2). Tynes saw he had contacted the victim's truck and called a mayday over the two-way radio. Lopez and Gomez proceeded to the scene. Mine officials immediately called emergency medical services. At 8:57 pm, Metro Fire and Rescue arrived, followed shortly by Metro EMS to begin extrication. The Pima County Sheriff pronounced Benitez dead at the scene at 10:34 pm. The cause of death was blunt force trauma.
