Excessive watering of haul-roads

Mines safety bulletin no. 94 | 22 January 2010 | Version 1

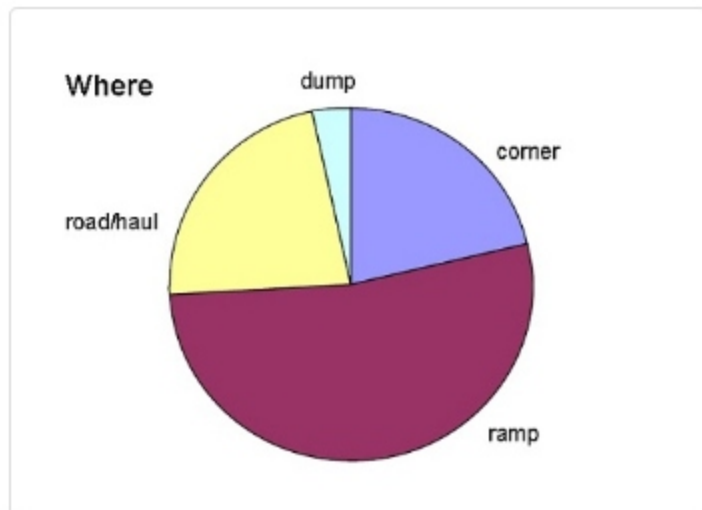
The number of incidents on haul-roads relating to over-watering is increasing. Most occur on ramps, (see location pie chart in Figure 1), and result in vehicle collisions with safety berms (bund walls).

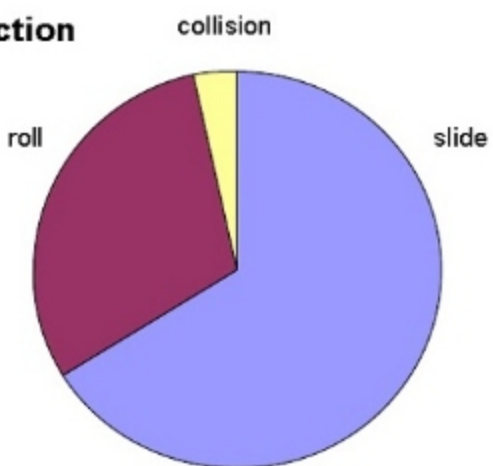
Action

While most water trucks have been fitted with spot sprays to alleviate over-watering, greater attention is needed to other causal factors, including steep grades, limited site distance, narrowing road ways, intersection design and/or slippery road surfaces. Figure 2 shows vehicle actions as a result of an over-watering incident and Figure 3 represents the types of vehicles involved in such incidents.

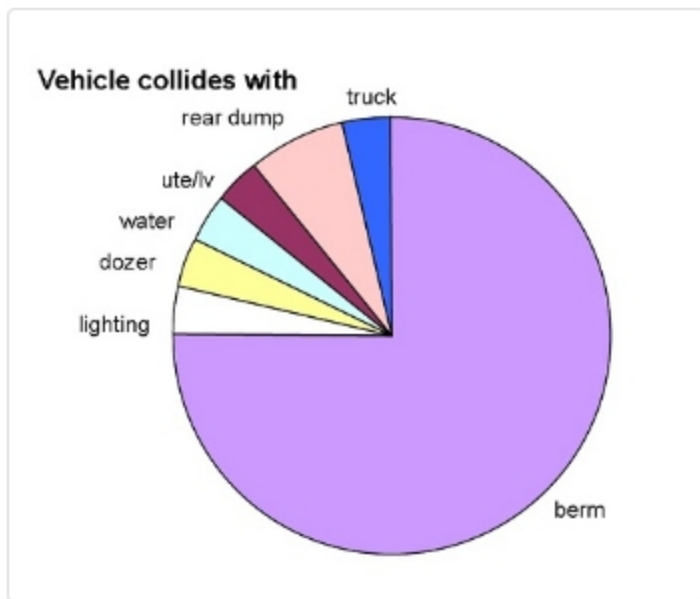
The design of the berms should not allow a ramp effect to assist the vehicle to topple. Mine operators need to realise that the effectiveness of the berm will depend on its width or thickness, its firmness and an effective designed height accounting for the largest vehicles in use. Figure 4 shows the proportion of collisions involving berms, emphasising the need for adequate and effective berm design.

- Mines' SOPs for dealing with excessive watering of haul-roads require urgent review (Section 129, the Coal Mining Safety and Health Regulation 2001(the Regulation)).
- Mines' risk assessments and SOPs for haul-road design, including safety berms, require urgent review (Section 128 (3) of the Regulation).
- The material types used by mines for road construction, including on the road surface to provide for frictional value, require urgent review (Section 128 (2) of the Regulation).
- Water trucks should be fitted with pulsed infusion systems that can be effectively controlled by the operator to manage the water output.
- Experienced operators should be utilised to water roads.
- Mine officials and vehicle drivers must ensure that the risk is as low as reasonably achievable.
