**NSW
Resources
Regulator**

INVESTIGATION REPORT

MAULES CREEK MINE TRUCK COLLISION

Maules Creek Mine 21 April 2018

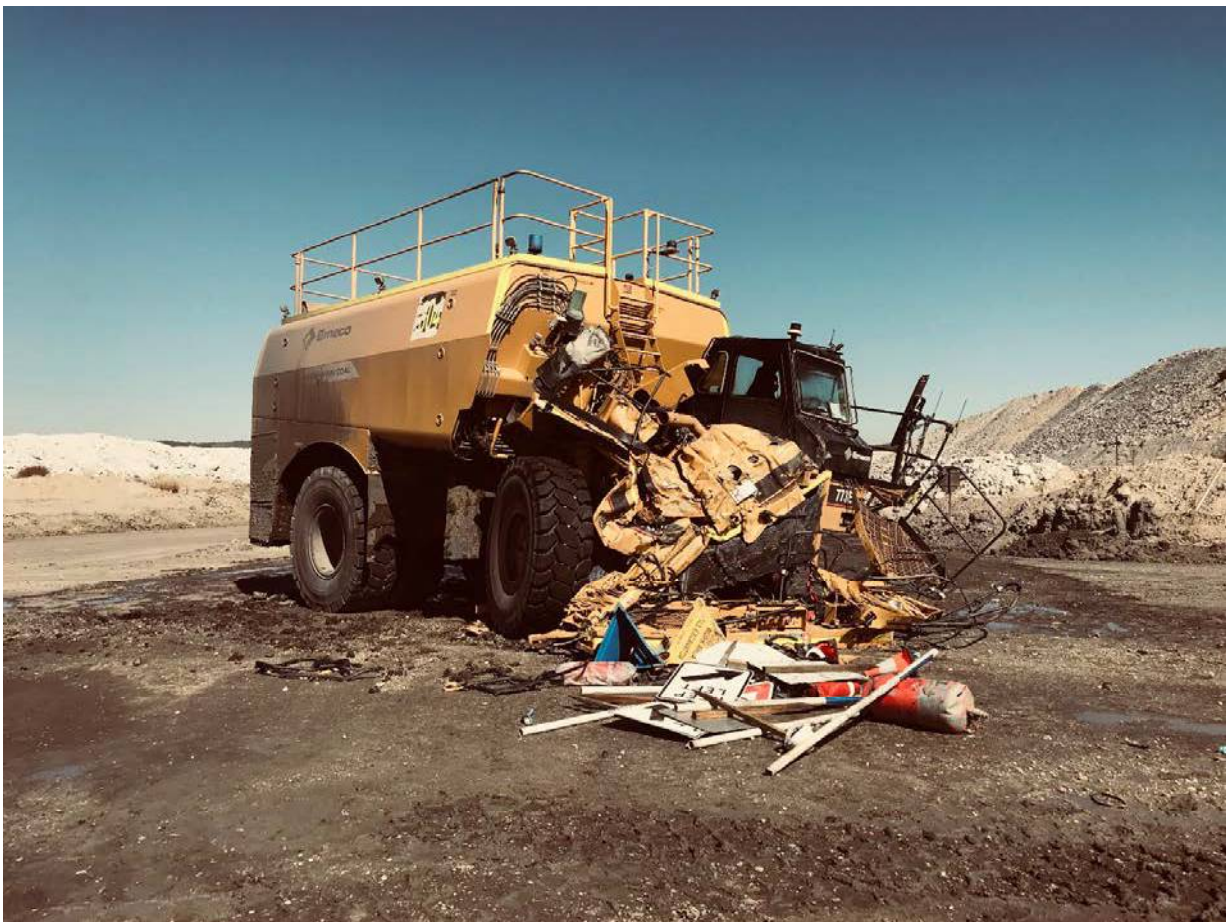
Figure 1 Damaged front end of service truck

As the two vehicles entered the intersection, both drivers realised a collision was imminent and attempted to take evasive action. The 100-tonne service truck collided with the side of the 500-tonne haul truck, resulting in catastrophic damage to the service truck. The haul truck stopped about 100 metres past the impact point.

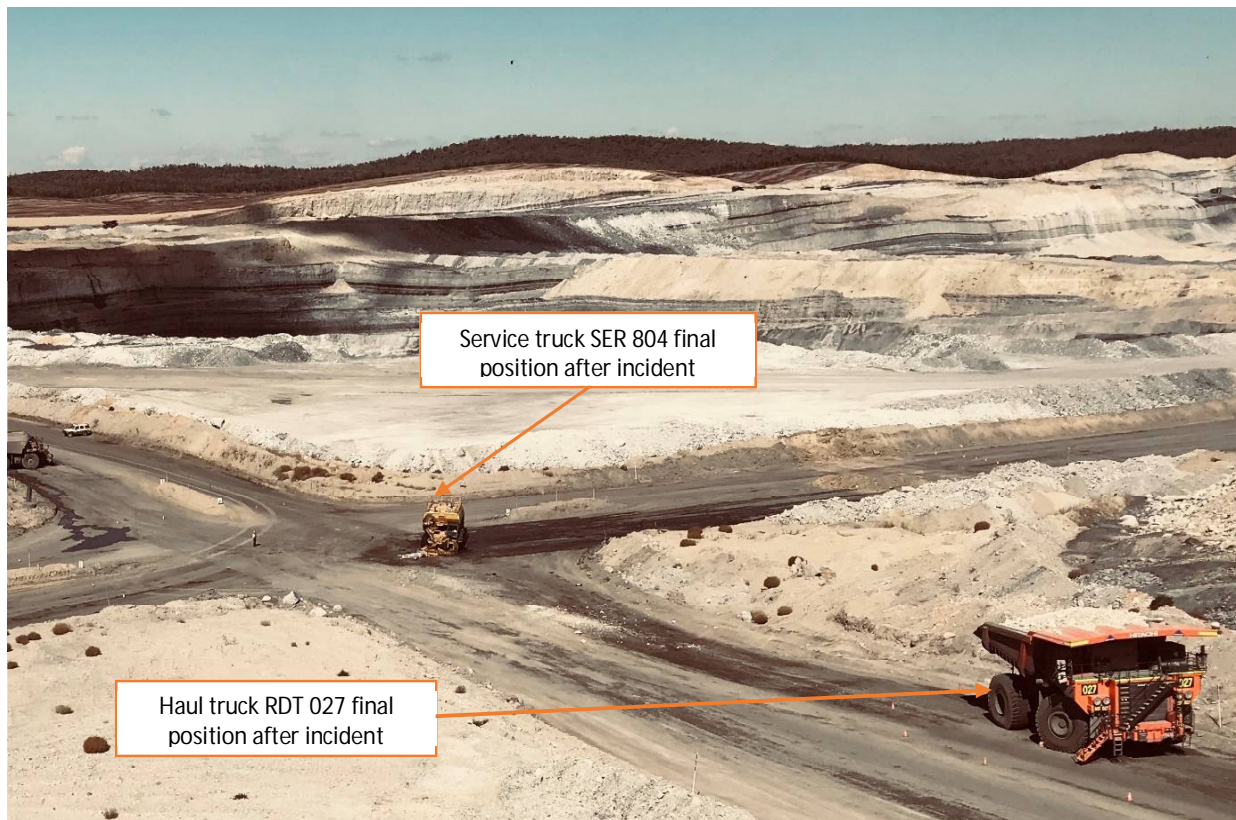
The final location of both vehicles immediately after the incident is shown in figure 2.

Figure 2 Four-way haul road intersection showing trucks involved in the collision

The haul truck operator told investigators that the windrows were high and impeded his view as he approached the intersection. The service truck suddenly appeared at the last minute to his left. He tried to accelerate in an attempt to avoid the collision, however the service truck collided with the rear of his truck, pushing his truck toward the median strip.

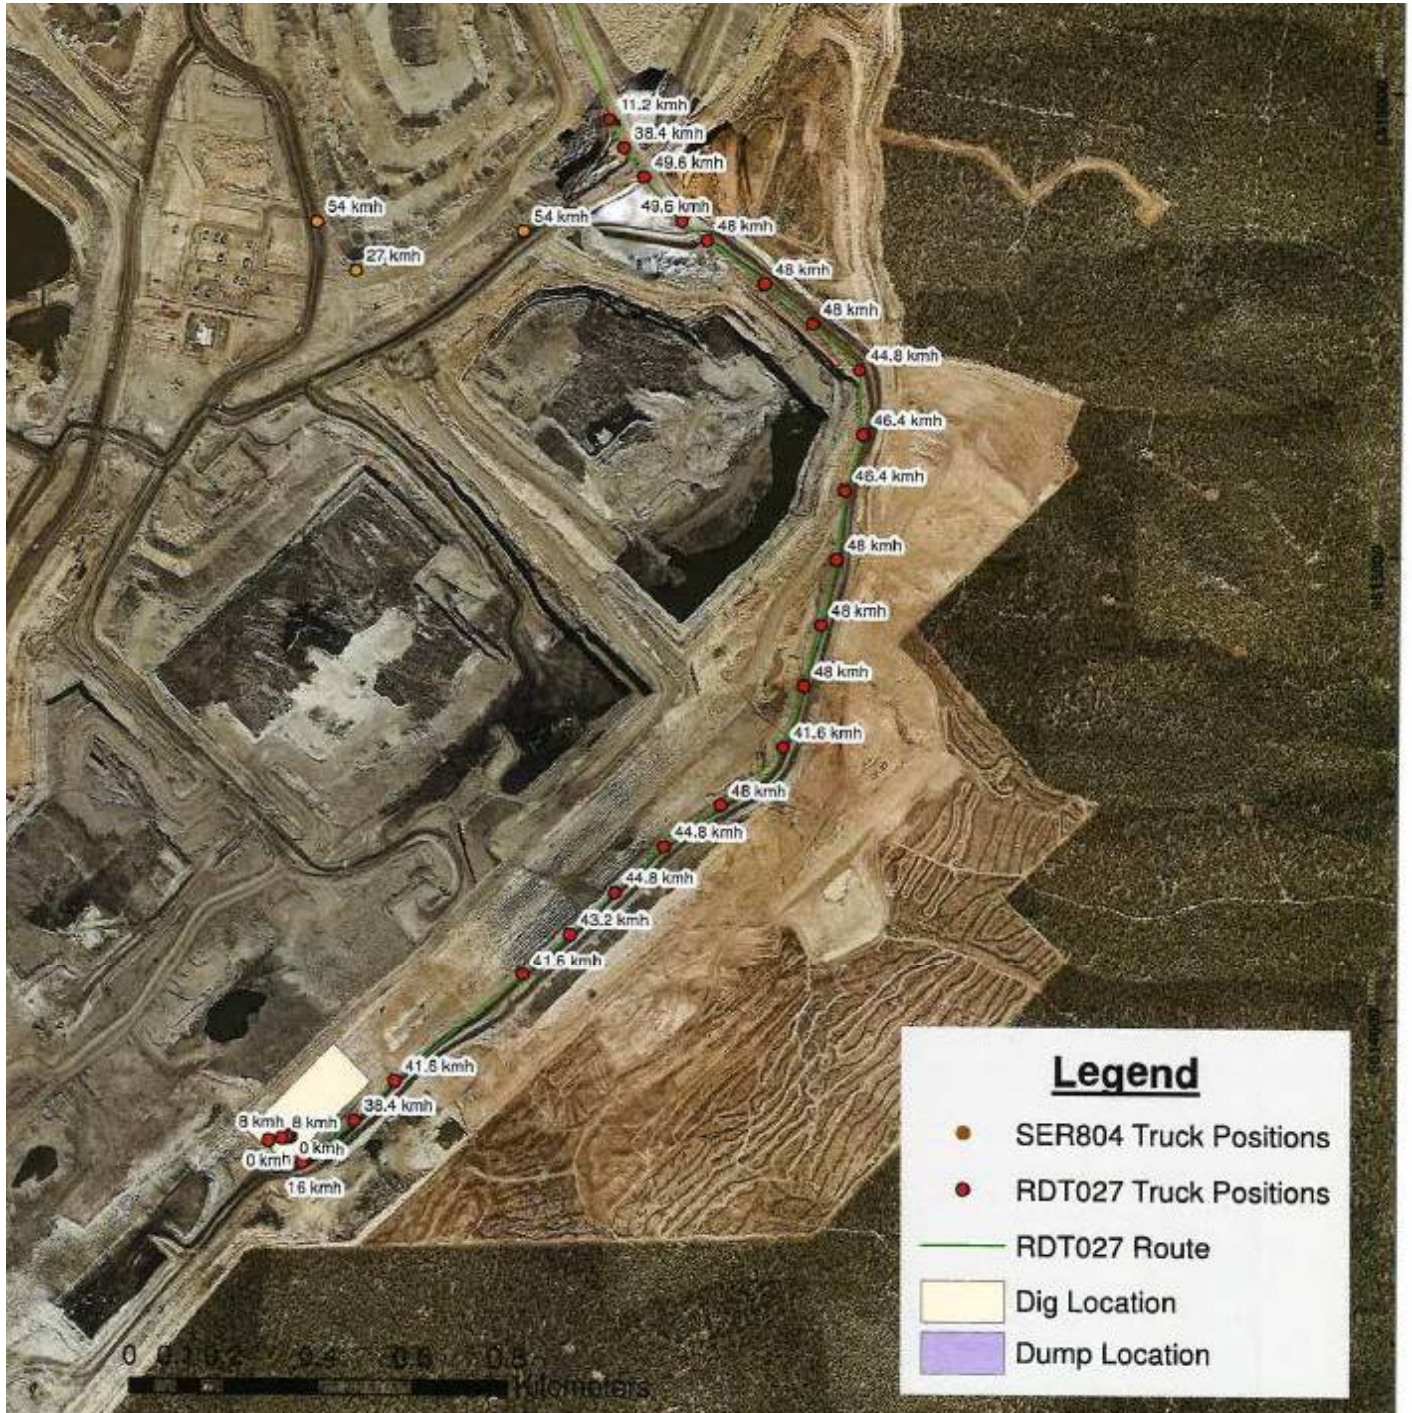
In the plan below, the movements of the haul truck are shown with the red dots and the movements of the service truck with brown dots. The tracking of the haul truck was quite constant, whereas the positioning of the service truck was infrequent and random.

The haul truck was travelling at 48.6 km/h at time of impact and the service truck was travelling at 54 km/h toward the intersection. According to the mine's safety management system, the maximum speed limit in the mine was 60 km/h. It appears that both vehicles were travelling at speeds that would indicate that they were not intending to slow or stop at the intersection. However, the speed of both trucks at the time of the collision is not known as both operators attempted to take evasive action immediately before the collision.

Figure 3 Maules Creek Coal Mine haul truck RDT027 and service truck SER804 speed tracking
