# Fires on mine sites

Mines safety bulletin no. 86 | 30 September 2008 | Version 1

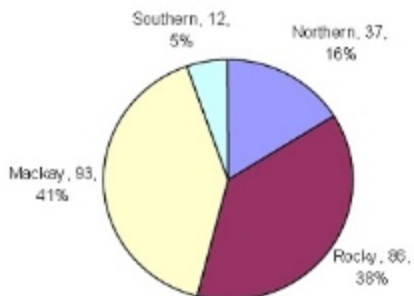
### Fires by Region

The first diagram shows where fires were occurring in the Department of Mines and Energy regions—Central Region has been broken up into Rockhampton and Mackay, for obvious reasons. It reports on the:

- number of fires on a vehicle or plant
- number of fires that have endangered the safety or health of a person.

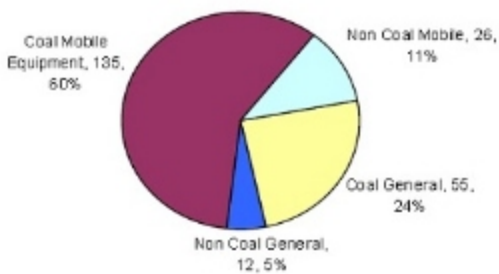
### Fire by type

The second diagram below shows the same data split 4 ways into:

- coal mining
- non-coal mining
- those specifically on mobile equipment
- general fires, such as
  - material handling, specifically belt conveying
  - process and coal preparation plants
  - cutting and welding incidents
  - any reported fire that did not have a stated mobile equipment involvement.

It is clear that coal mines and mobile equipment account for the vast majority of the fires.

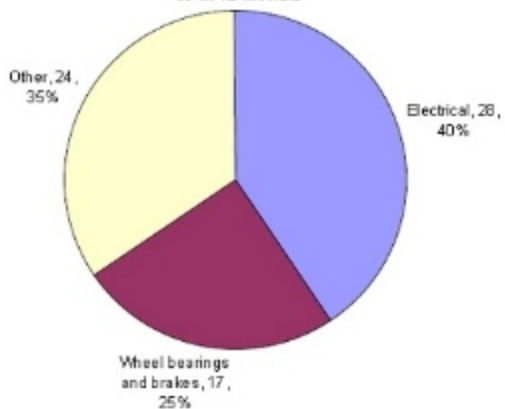
### Mobile equipment fires not in the engine bay

The third diagram shows the 69 fires which occurred on mobile equipment but not in the engine bay.

The 28 fires reported as having an electrical source included:

- alternator
- starter motor jammed
- overheated cables
- cables shorted due to burnt insulation (engine hot surface).

Twenty-four fires were from a myriad of causes including:

- steering hose blown
- frictional heat from rubbing against moving part
- fires that did not have a cause stated in the report.

The remaining 17 fires were wheel bearings (mainly on road style haulage trucks and trailers) and brakes (heavy transport float).

Improved inspection and maintenance of the mobile equipment would have detected and removed many of these 'elsewhere on the vehicle' sources and prevented the fire from occurring.

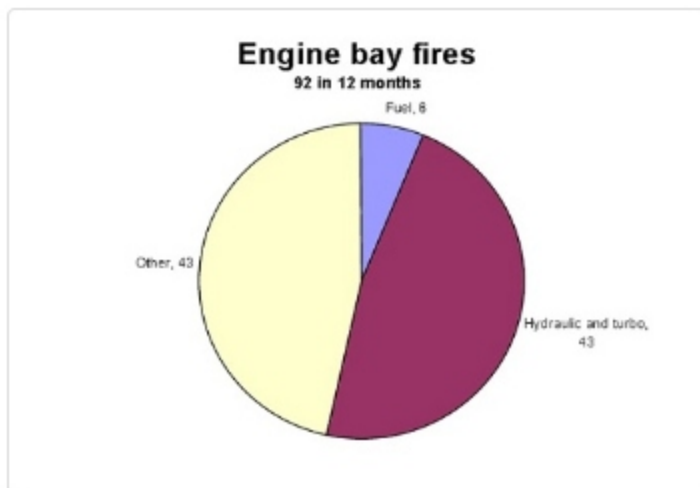
In the fourth diagram below, of the 92 fires in the engine bay, the turbocharger was mentioned in 43 cases.

Consistently reported were 'hose failed and sprayed oil onto the turbo charger' or 'the turbo charger failed causing a fire from the resultant cooling oil leak'.

It would be expected that diesel fuel fires would predominate in an analysis of engine bay fires but diesel fuel from cracked or leaking fuel lines was remarkably low in occurrence. This is testament to the modification work done by equipment manufacturers in answer to a similar rise in engine bay fires almost a decade ago.

The 'other' category, also with 43 fires, indicates poor maintenance practices and includes such things as:

- rag and flammable material left in the engine well
- rag fell onto hot engine
- fuel or oil spilled by fitter onto hot engine
- loose oil and fuel filter housing.

Quality maintenance practices are required to control these hazards and prevent the all-too-common occurrence of fire. Very few reported fires in the engine bay have resulted in any change to fire control, the fires will continue as long as there are no positive controls put in place.

Routine replacement of hoses before imminent failure, routine change out of critical components, such as the turbocharger, are just 2 of the preventative measures that are well-known, easily achieved but rarely feature in mines maintenance practices. Spending less on maintenance is not a viable costcutting strategy. The pain of poor maintenance will last long after the pleasure of cost cutting.
