SAFETY ALERT

Inappropriate maintenance practices and fire protection lead to major plant fire

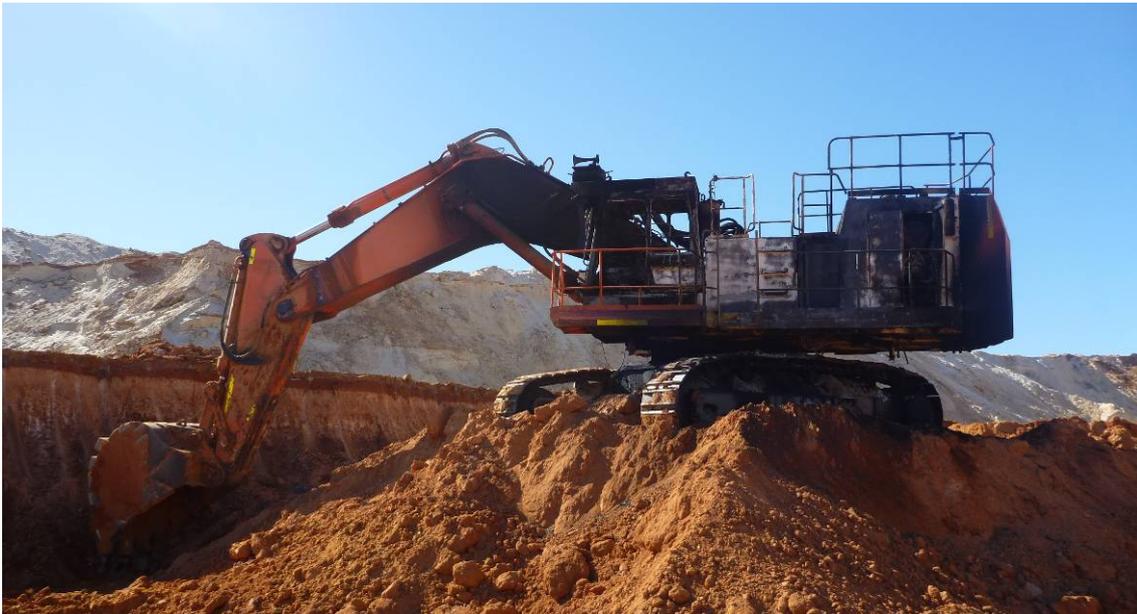
Attempts to control the fire with hand held extinguishers were unsuccessful and the excavator was destroyed, refer photo 1.

Photo 1 - Excavator after fire was extinguished.

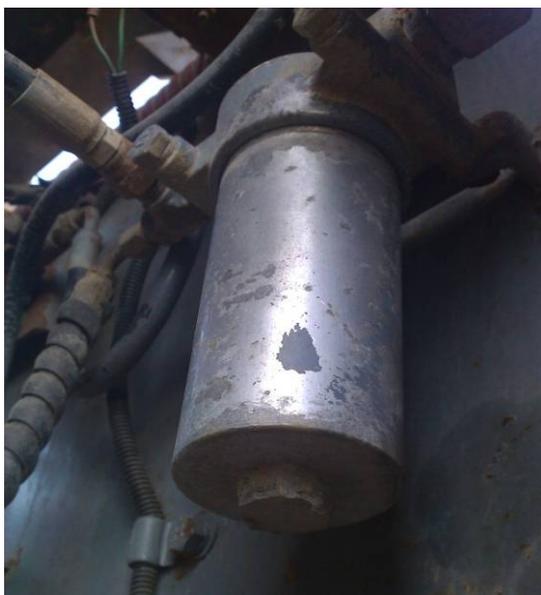
The oil filter housing was designed to be installed with a socket or ring spanner applied to a cast nut at the bottom of the housing, refer photo 2.

Photo 2 – Oil filter housing cast removal nut.

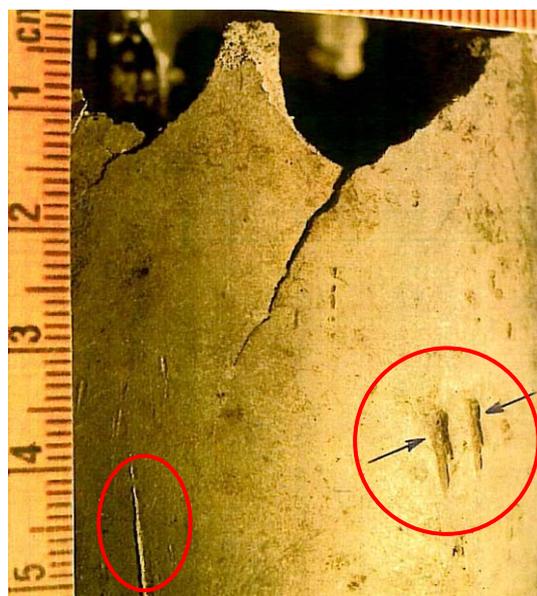
A detailed inspection of the excavator was conducted by a consulting forensic fire investigator who concluded that *'the fire originated from a cracked aluminium alloy hydraulic oil filter housing that allowed an escape of oil that ignited on contact with hot engine components'*.

Numerous sharp tool marks on the oil filter housing recovered from the excavator after the fire suggested the housing was installed with a stillson wrench or other similar tool and most likely over tightened, refer photo 3. The investigator concluded that *'cracking of the housing originated at the tool marks'*.

Photo 3 – Stillson marks and cracks on filter housing.

- Maintenance activities should always be undertaken in accordance with the manufacturer's recommendations.
- Maintenance people should be competent for the task they carry out and should always use the correct tool for the job. Maintainers should not improvise by using inappropriate tools
- Equipment components should be carefully inspected before being installed; damaged or worn components should always be replaced.
