Fires on mine sites

Mines safety bulletin no. 86 | 30 September 2008 | Version 1

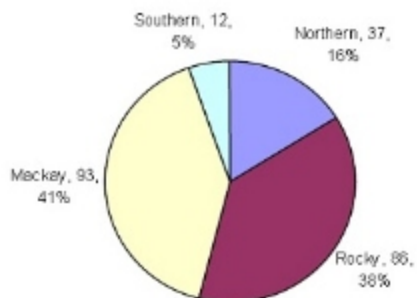
Fires by Region

The first diagram shows where fires were occurring in the Department of Mines and Energy regions—Central Region has been broken up into Rockhampton and Mackay, for obvious reasons. It reports on the:

- number of fires on a vehicle or plant
- number of fires that have endangered the safety or health of a person.

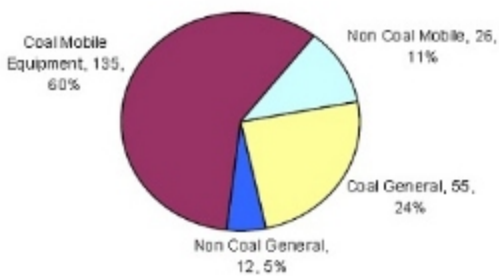
Fire by type

The second diagram below shows the same data split 4 ways into:

- coal mining
- non-coal mining
- those specifically on mobile equipment
- general fires, such as
 - material handling, specifically belt conveying
 - process and coal preparation plants
 - cutting and welding incidents
 - any reported fire that did not have a stated mobile equipment involvement.

It is clear that coal mines and mobile equipment account for the vast majority of the fires.

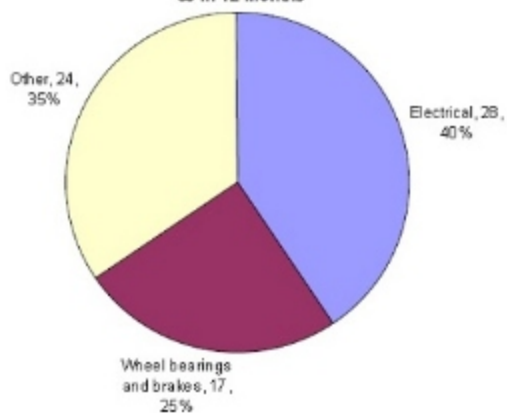
Mobile equipment fires not in the engine bay

The third diagram shows the 69 fires which occurred on mobile equipment but not in the engine bay.

The 28 fires reported as having an electrical source included:

- alternator
- starter motor jammed
- overheated cables
- cables shorted due to burnt insulation (engine hot surface).

Twenty-four fires were from a myriad of causes including:

- steering hose blown
- frictional heat from rubbing against moving part
- fires that did not have a cause stated in the report.

The remaining 17 fires were wheel bearings (mainly on road style haulage trucks and trailers) and brakes (heavy transport float).

Improved inspection and maintenance of the mobile equipment would have detected and removed many of these 'elsewhere on the vehicle' sources and prevented the fire from occurring.

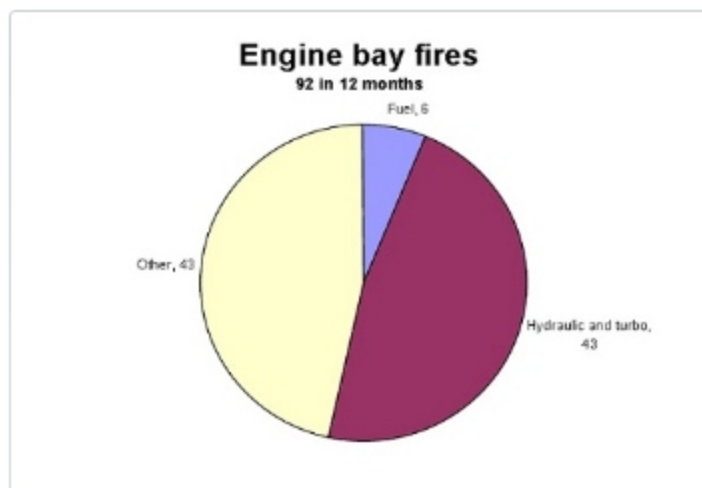
In the fourth diagram below, of the 92 fires in the engine bay, the turbocharger was mentioned in 43 cases.

Consistently reported were 'hose failed and sprayed oil onto the turbo charger' or 'the turbo charger failed causing a fire from the resultant cooling oil leak'.

It would be expected that diesel fuel fires would predominate in an analysis of engine bay fires but diesel fuel from cracked or leaking fuel lines was remarkably low in occurrence. This is testament to the modification work done by equipment manufacturers in answer to a similar rise in engine bay fires almost a decade ago.

The 'other' category, also with 43 fires, indicates poor maintenance practices and includes such things as:

- rag and flammable material left in the engine well
- rag fell onto hot engine
- fuel or oil spilled by fitter onto hot engine
- loose oil and fuel filter housing.

All of these could be controlled with increased vigilance and care of maintenance personnel.

Quality maintenance practices are required to control these hazards and prevent the all-too-common occurrence of fire. Very few reported fires in the engine bay have resulted in any change to fire control, the fires will continue as long as there are no positive controls put in place.

Routine replacement of hoses before imminent failure, routine change out of critical components, such as the turbocharger, are just 2 of the preventative measures that are well-known, easily achieved but rarely feature in mines maintenance practices. Spending less on maintenance is not a viable costcutting strategy. The pain of poor maintenance will last long after the pleasure of cost cutting.
