UNITED STATES
DEPARTMENT OF LABOR
MINE SAFETY AND HEALTH ADMINISTRATION
Metal and Nonmetal Mine Safety and Health

REPORT OF INVESTIGATION

Fatal Powered Haulage Accident
July 27, 2017

**Fatal Powered Haulage Accident
October 31, 2017**

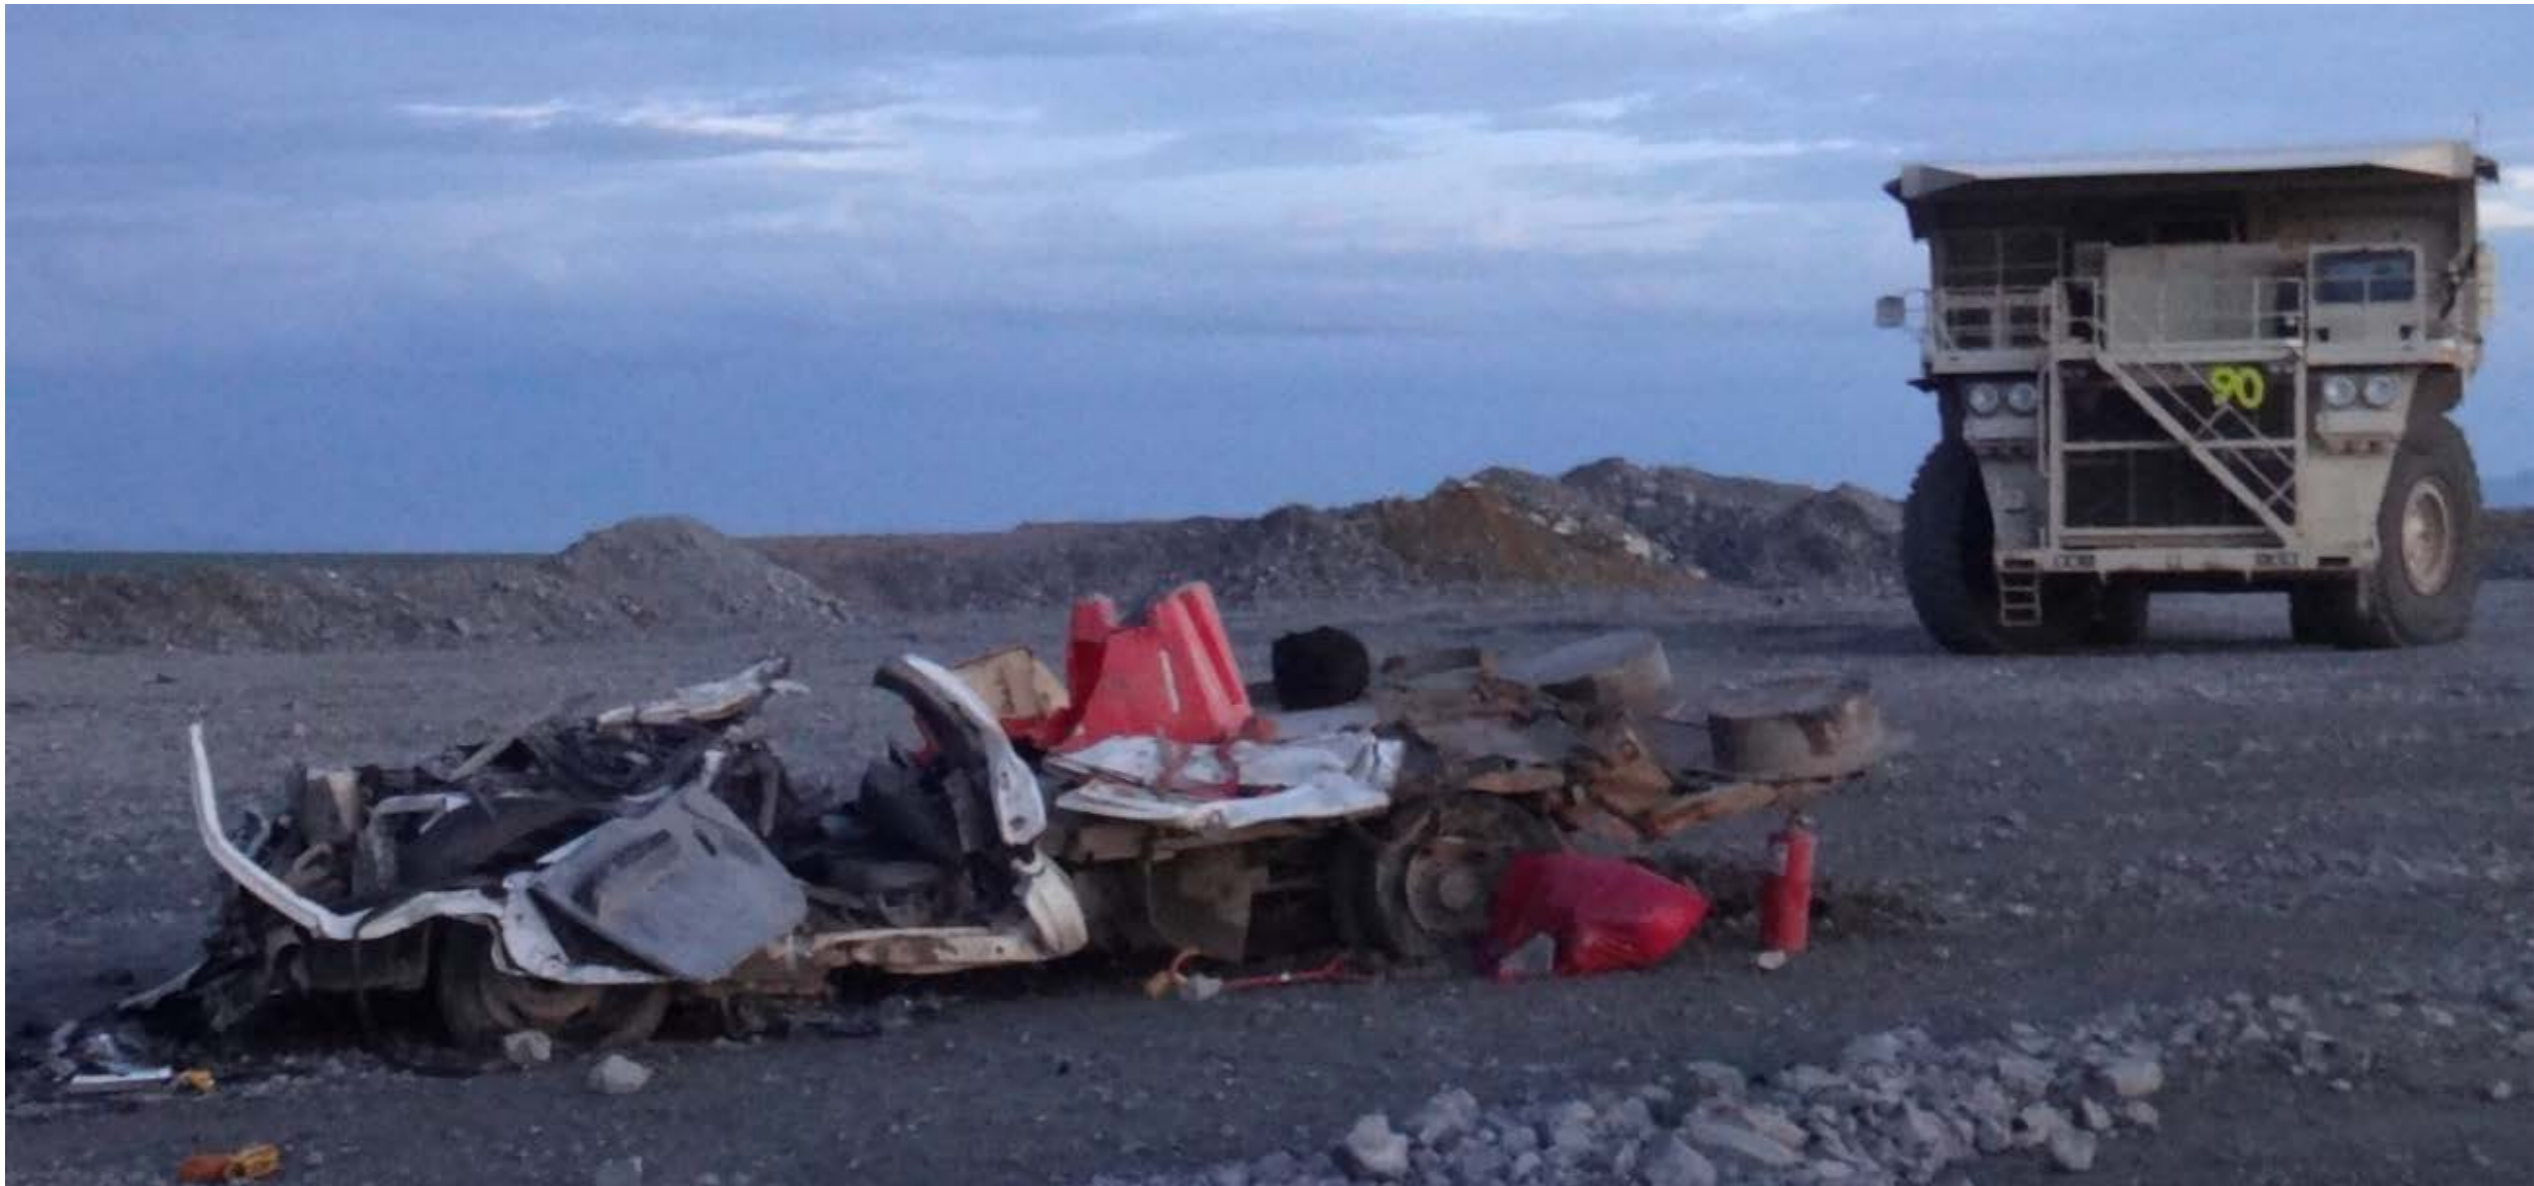
At 8:20 p.m. the victim parked his LV next to a windrow of material used to delineate the western boundary of the dump site. The LV's operating lights and strobe light had been turned off. Personal cell phone records indicate that the victim had been using his cellphone while he was at the dump site (one of the few places on site which had reception).

At 8:33 p.m., a Komatsu 930E-4, 320-ton haul truck driven by Tynes entered the dump site and dumped his load. As Tynes began leaving the dump site another truck entered the dump area and Tynes made a large arcing turn to allow more room for the second haul truck - resulting in the LV being run over and completely destroyed.

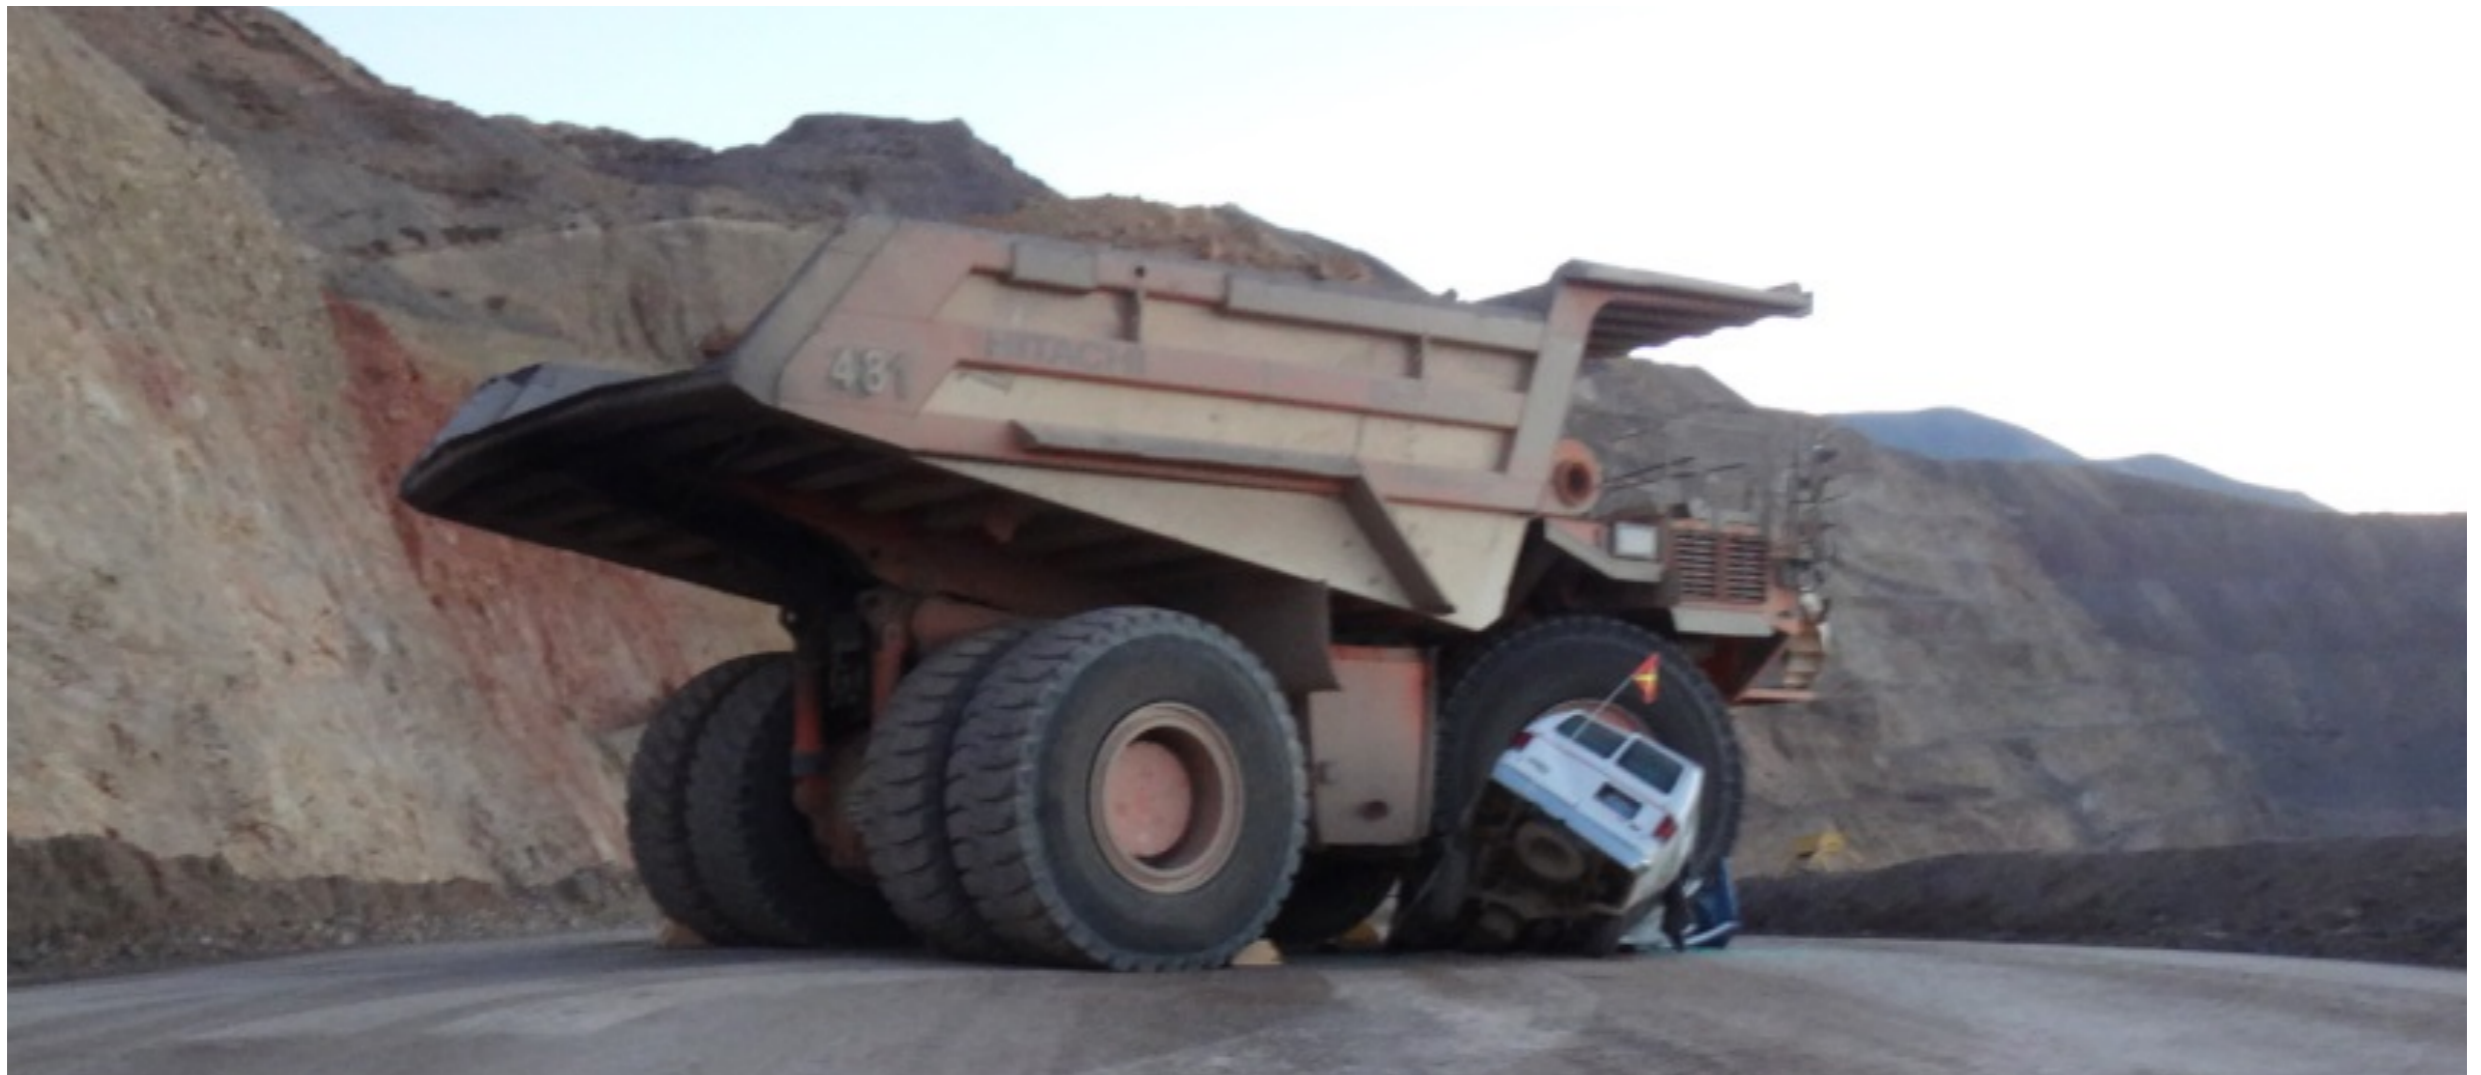
During a stoppage for a blast, a light vehicle containing driver and eight passengers was parked on a haul road, in front and to the side of a haul truck. After the stoppage was cleared, the haul truck driver started forward to make a U-turn. The driver and one passenger were unable to exit the vehicle before the collision.
