# SAFETY BULLETIN

## Exploding lead acid batteries

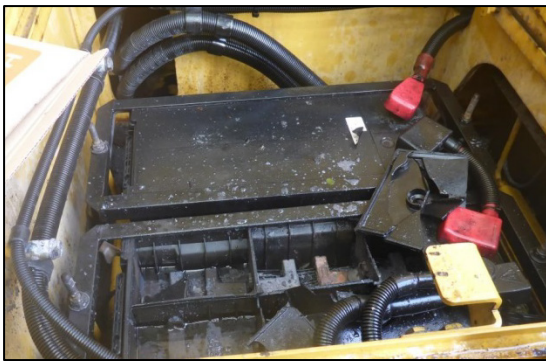
Image 1: Failed battery in Cat 993K front end loader

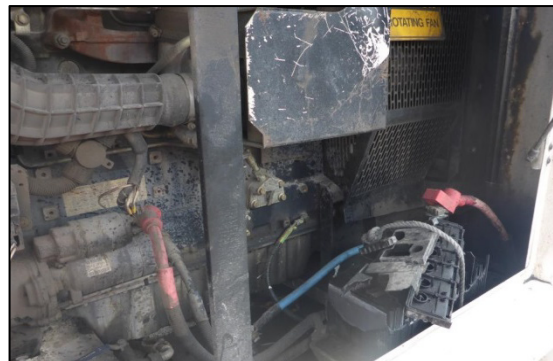
Image 2: Failed battery in 100kVA generator
