Review and Analysis of Tyre Related Accidents and Incidents – an ACARP¹ Study to Improve Tyre & Rim Maintenance and Operational Safety of Rubber Tyred Earthmover Equipment²

Tilman Rasche³, & Tom Klinge

Klinge & Co.

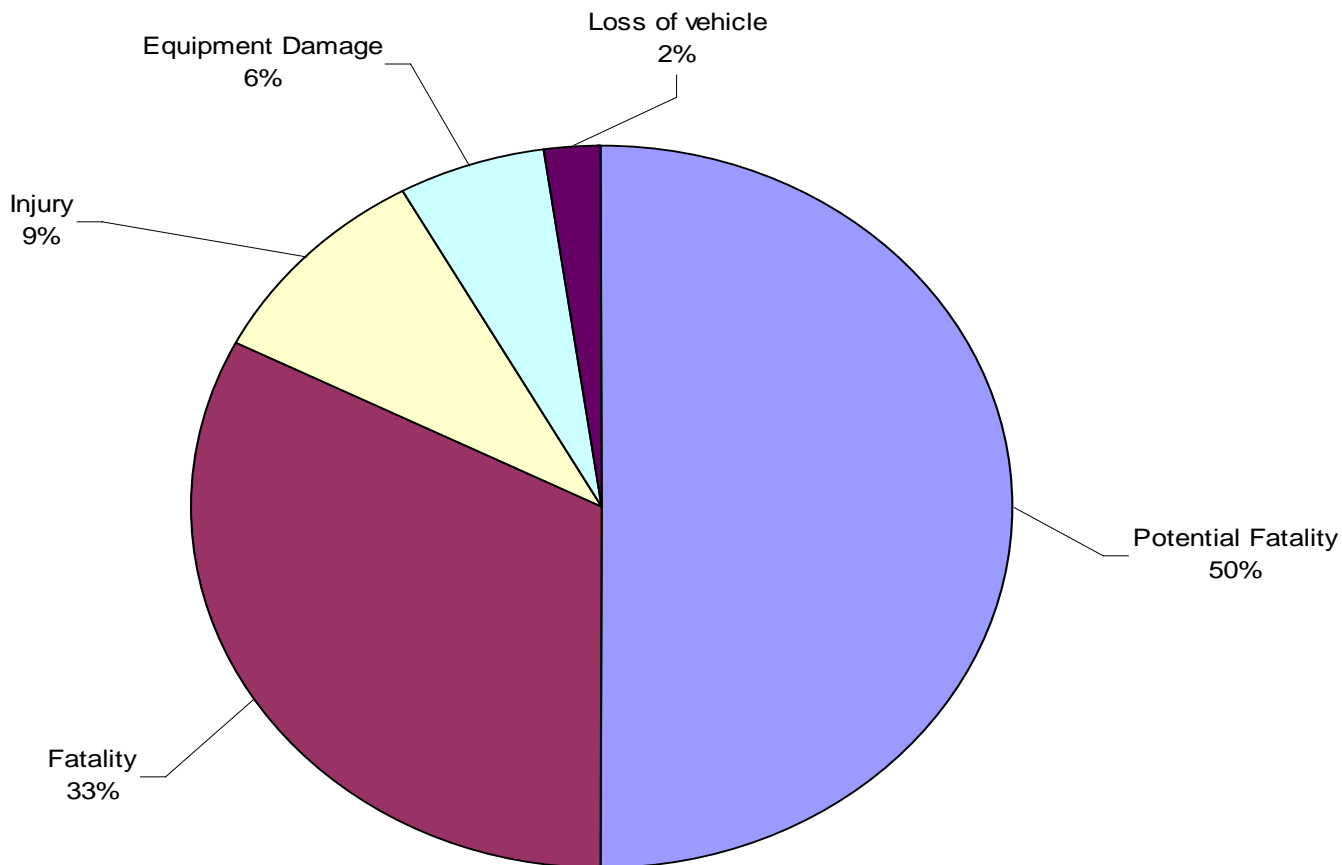
Figure 1 - Actual & Potential Consequences to Tyre & Rim related Incidents & Accidents

As shown in Figure 1, 33% of all cases covered by this review resulted in the death of the tyre serviceman or personnel involved in the work. A further 50% of all incidents and accidents were classified as potential fatalities based on their similarity to other fatality cases. The combined percentage of 83% - actual and potential fatal outcomes - clearly suggests that working with tyres and rims in either a maintenance setting, or subsequent operational setting must be strictly controlled through a number of initiatives at a number of levels.

These hazard characteristics and examination of the actual or potential injury outcome supports that OTR tyre and rim related work can result in a disproportionately high incidence, larger than 80% (ref Figure 1), of fatal or potential fatal outcomes for the personnel involved, requiring strict controls at the management and team level, and by the individual carrying out the task.

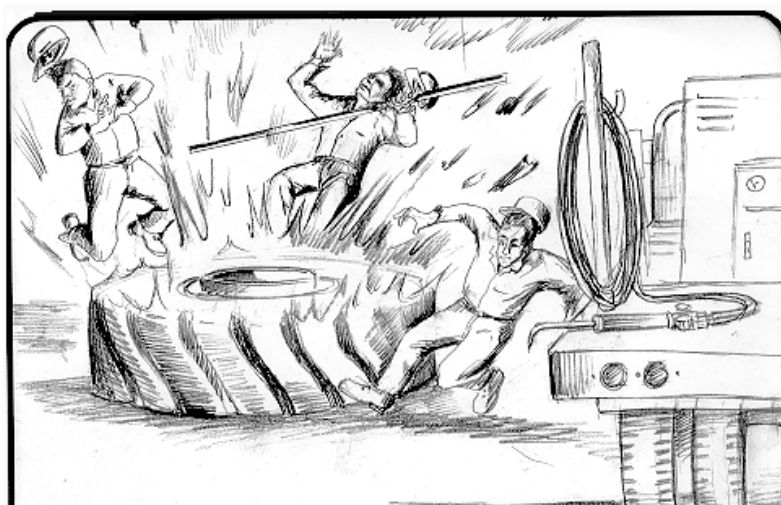
Heating of wheel fastening systems is a key root cause to many tyre and rim related fatalities. This work practise must be eliminated. Sketch from [3].

- Heating of fitted tyre / wheel assemblies using any heat source such as an oxyacetylene flame, to loosen tight or seized corroded wheel fastening system, i.e. nuts and studs, must be eliminated. Such heating may produce pyrolysis in the tyre chamber (even when fully deflated) which is known to escalate into a high energy and violent chemical explosion. Alternative safe methods to loosen wheel nuts or studs, e.g. using hydraulic tools must be sought. Analysis of the incident/accident data has shown that pyrolysis tyre events contribute 21% to the overall incident and accident count and is therefore one of the root sources of harm.

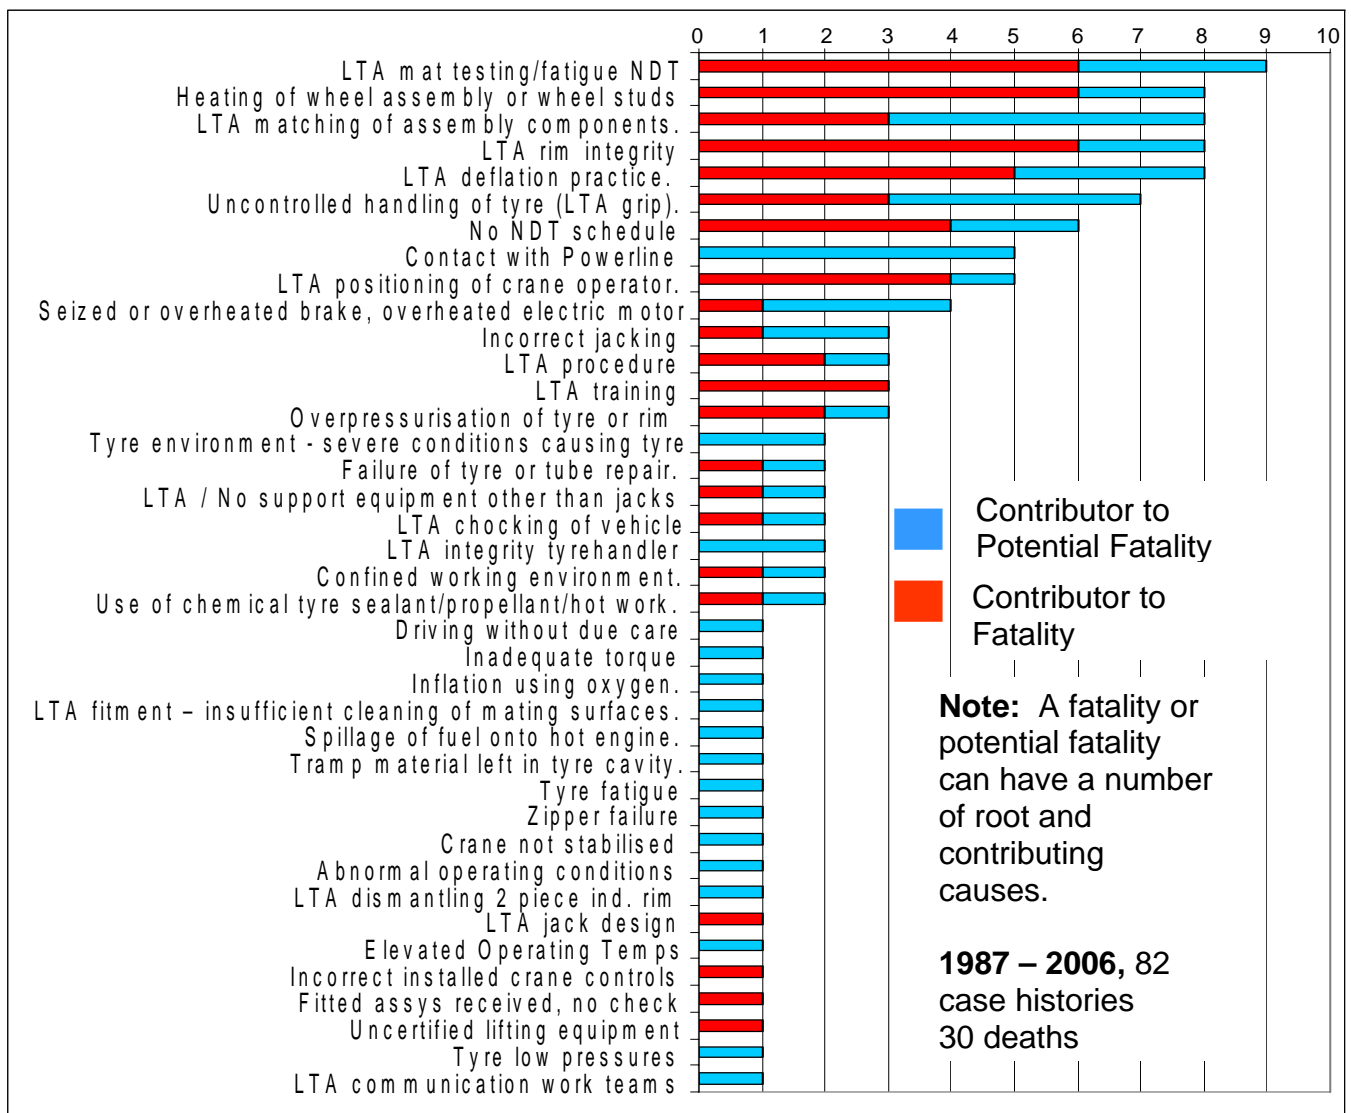
Figure 2 – Fatalities & Potential Fatalities – Root & Contributing Causes

A further breakdown as to the underlying acts and conditions leading to the main consequence categories, fatalities and potential fatalities, is shown in the Pareto diagram in Figure 2.

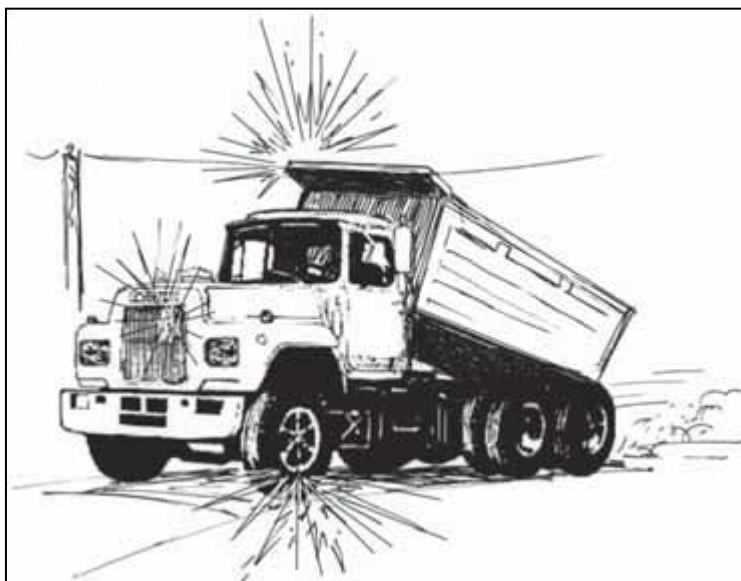
Accidental contact with overhead powerlines or electrification by lightning strike is known to cause pyrolysis and subsequent violent explosion of in some or all vehicle tyres. This hazard can be best eliminated by designing roads away from powerlines. (sketch from [2])

- Operational situations that may result in contact with powerlines must be eliminated. Similarly situations involving lightning strike to rubber tyres vehicles must be considered also and included in a review of vehicle operational and mines rescue practises. The review should also include other scenarios known to cause conditions conducive to tyre fires and pyrolysis events such as seized or overheating of brakes or wheel motors.
