Rear dump truck drives over light vehicle

Mines safety alert no. 237 | 18 December 2009 | Version 1

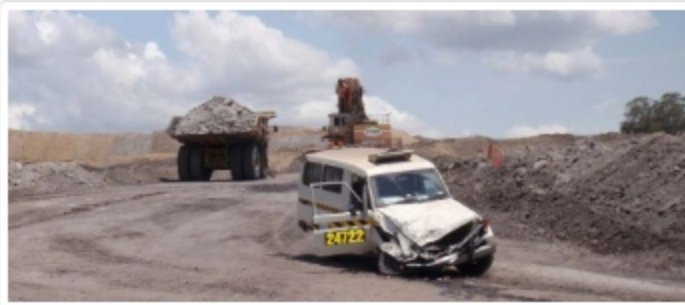
During dayshift, a loaded Cat 785D Rear Dump Truck was travelling off a bench towards the intersection with the ramp leading out of the pit. At the same time, a supervisor was travelling down the ramp in a Toyota Troop Carrier. The supervisor stopped at the intersection to let the truck exit the bench and to turn right onto the ramp. As the truck entered the ramp, the right front wheel (off driver's side) ran over the bonnet of the troop carrier on the driver's side. The truck continued up the ramp and only stopped after the supervisor contacted the truck driver via the two way radio. Nobody was injured in this incident.

- The truck was travelling parallel to the light vehicle prior to the vehicles reaching the intersection. They were separated by the bunding on the ramp which restricted both drivers' visibility.
- The intersection design restricted visibility.
- In exiting the bench, the truck tended to cut the corner due to the difference in grades between the bench and the ramp.
- At a point in the turning arc, the troop carrier was completely hidden behind the A pillar of the truck's cabin.
- The truck driver did not see the light vehicle due to the bunding along the edge of the ramp and warning lights which were ineffective during daylight hours.
- The supervisor may have been distracted whilst testing the radio.

1. Separate light vehicles from heavy vehicles via designated, suitable roads.
2. Review the design of intersections to optimise the field of vision for heavy vehicle operators ensuring:
 - Approaches to the intersections are constructed at a flat grade for a minimum distance of at least the length of the longest vehicle using the intersection.
 - Installation of a median bunding / physical barrier to provide right angle entry to roads and to slow down turning vehicles.
 - Roads at intersections are at 90° to allow for maximum visibility with windrows tapered as intersections are approached.
3. Use proximity detection and collision avoidance technology.
4. Review the effectiveness of the systems used to make light vehicles conspicuous during daylight hours.
5. Provide appropriate signage.
6. Review the effectiveness of communication procedures where vehicles interact.
