SAFETY ALERT

FIRE TRAPS TRUCK DRIVER

Report No: SA 04 02 **File No:** 288950000 **Date:** 16 January 2004

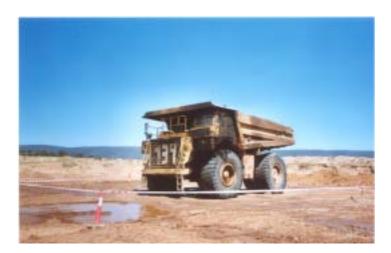
- (a) The hydraulic hose from the tray lift cylinder had burst, spraying oil over the hot turbocharger, the tray and all sides of the driver's cab.
- (b) Although the engine had been stopped, the weight of the tray on the hoist cylinder caused oil to continue spraying out and feeding the fire.

- Hydraulic hoses were not in good condition
 - A fixed fire extinguishing system had not been installed.
 - The fibreglass engine cover provided additional fuel to the fire because it was not fire resistant.
 This contributed to preventing use of the second means of escape. The fire was more intense on the engine side of the driver's cabin.

- Shielding had not been fitted around the exhaust turbochargers.
 - Oil leaks were evident at a number of locations on the vehicle.
 - The engine shut down system operated successfully although it was not fail-safe.

Burnt oil all over cab, windows and handrails

- (a) Provide effective engineering barriers to minimise risk from fires on large vehicles.
- (b) Use an appropriate risk analysis process to identify the appropriate engineering barriers, consider:-

- Automatic fire suppression systems which also shut down the engine system, after an appropriate delay, to suit the type of vehicle/equipment
 - Use of fire resistant engine covers

- Adopting a rigorous hydraulic hose management system which includes detailed discard criteria, use of factors of safety considerably over 4 to 1 and attention to location and restraint of hoses.

- Use of appropriate shields around turbochargers
 - Regularly cleaning and examination of engines to facilitate identification and repair of oil leaks

- Ensuring engine shut down systems are fail safe (Do not need electric power to stop engine)
- (c) Implement a process to progressively comply with MDG15 Guidelines for Surface Mobile and Transportable Equipment for Use in Mines.
